SUBJECT : BOARD OF ENQUIRY, COLLISION-HMCS "WALLACEBURG"
AND HMCS "TROIS RIVIERES".

BOARD OF ENQUIRY
COLLISION - H.M.C.S. "WALLACEBURG" AND "TROIS RIVIERES"

REPORT OF COLLISION OR GROUNDING*(King's Regulations and Admiralty Instructions, Articles 1167 and 1170.)*

H.M.C.S. "TROIS RIVIERES"

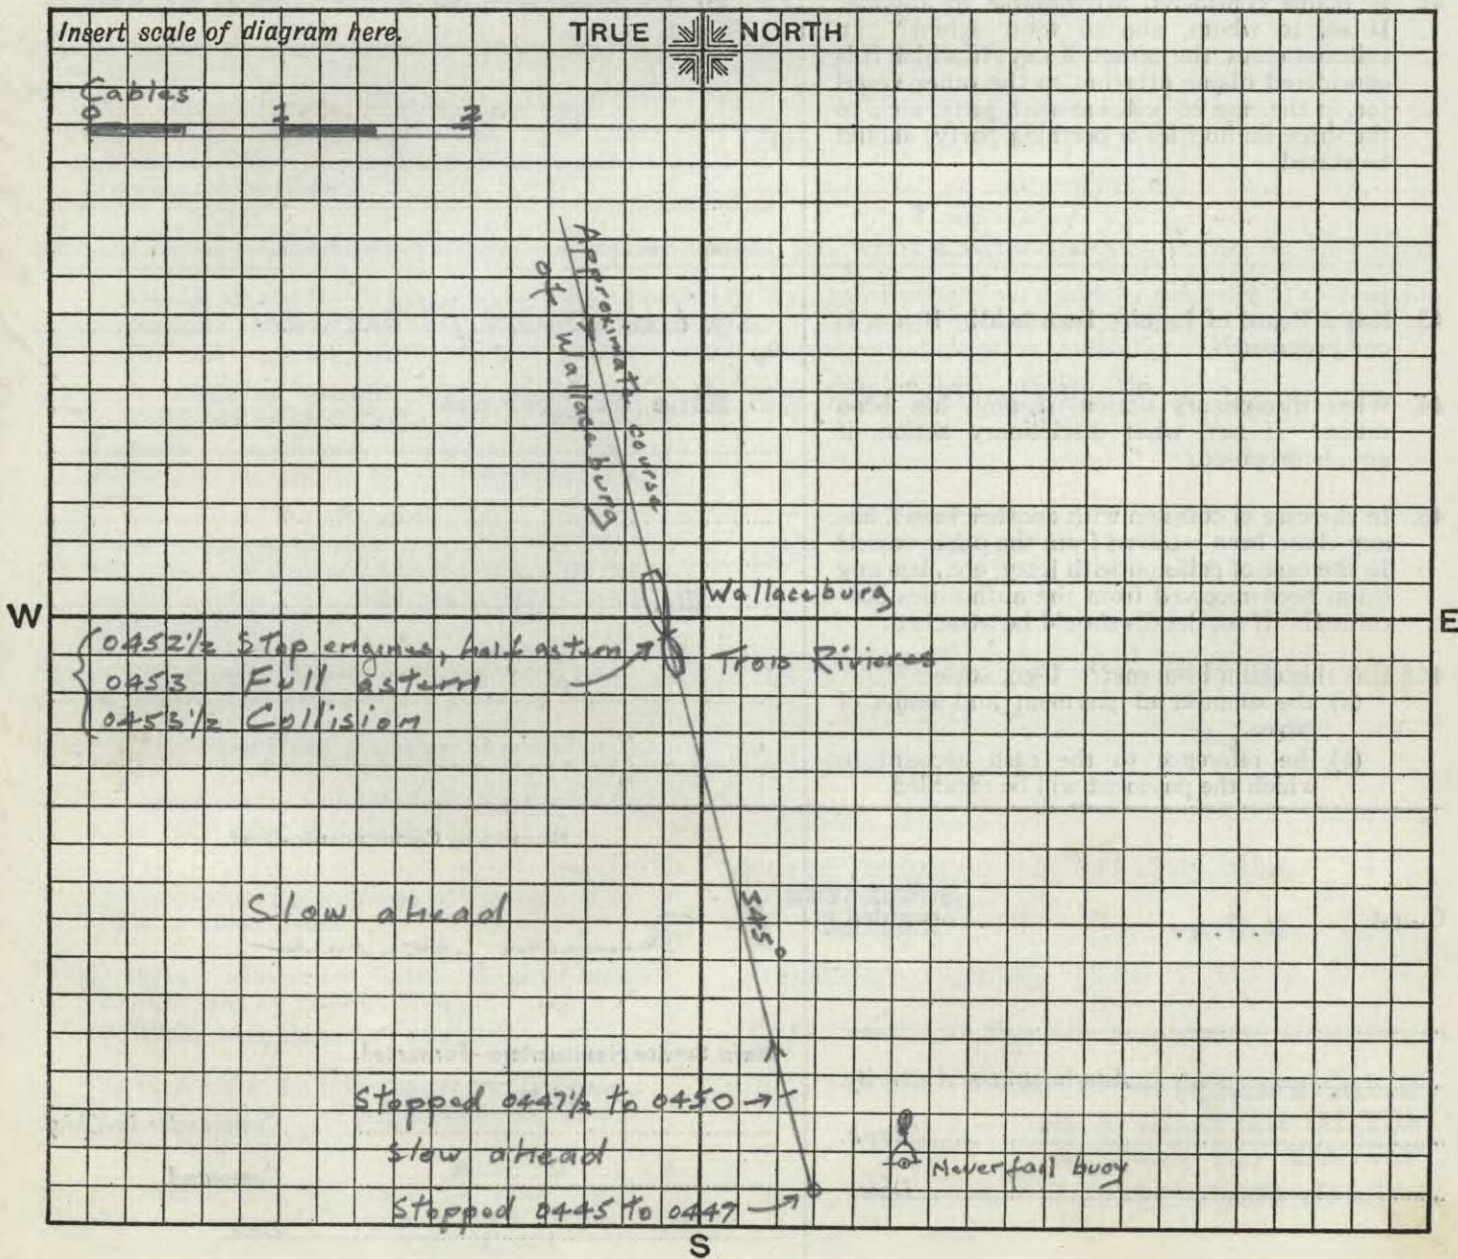
1. Date, time, and place/position of collision/grounding.

June 26 1944, 0453½ (zone plus 3)

and distance approx. 335°-3 cables from
("Neverfail" buoy.)

345° - 7 knots

Approx. reciprocal course, 10 knots.

0452½ light observed - 0453 ship sight

345°, ½ cable (lights visible at

Diagram illustrating relative positions, and movements, of vessels prior to collision, to be completed, if possible, in all cases of collision. The diagram may also be used for the plan of the place where the ship grounded, but not for the track chart.

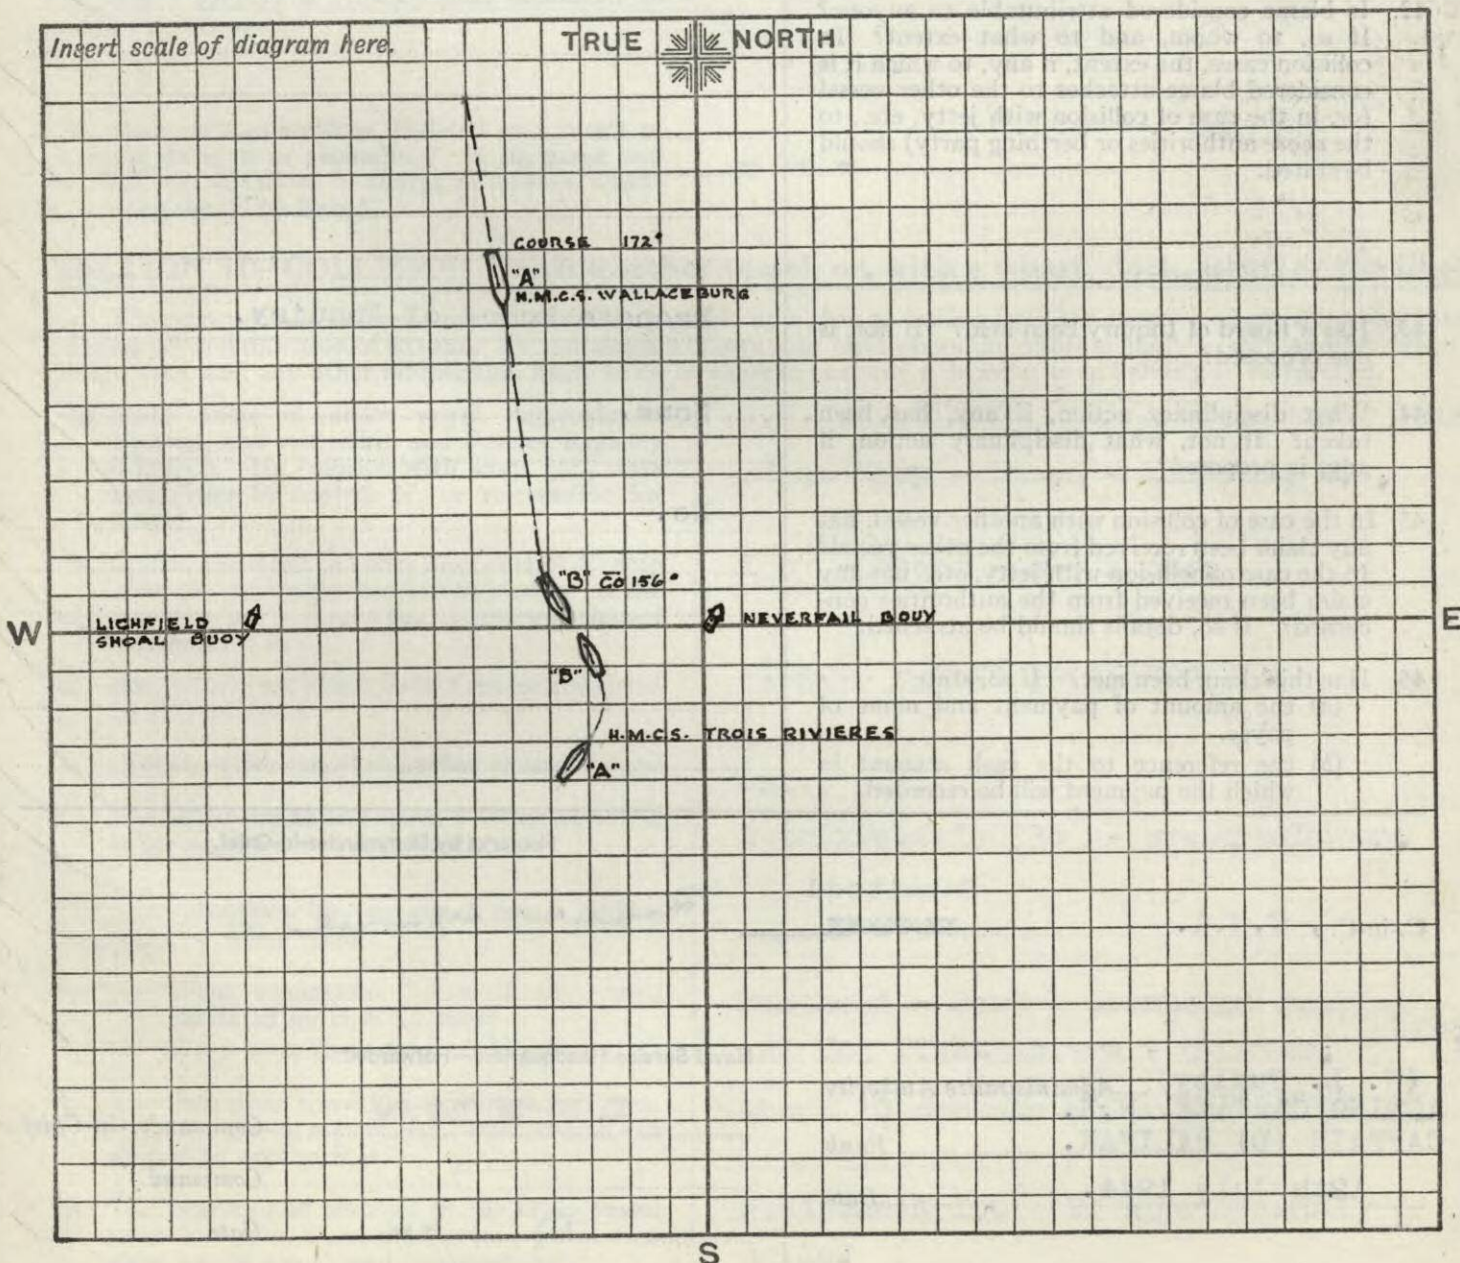
H.M.C.S. "WALLACEBURG" burning auxiliary
 port and starboard lights - regular mast-
 head - no obstructions.

Sound signals observed to be efficient
 by both ships.

Diagram illustrating relative positions, and movements, of vessels prior to collision, to be completed, if possible, in all cases of collision.
 The diagram may also be used for the plan of the place where the ship grounded, but not for the track chart.
