The Salvage of MV *Essi Silje* and Lloyd's Arbitration Hearing¹

by Edwin S. Chan

In 1982 the chemical tanker MV *Essi Silje* caught fire and was abandoned in the North Atlantic. The Canadian naval supply ship, HMCS *Protecteur*, undertook the salvage operation before the arrival of the salvage tugs. The vessel was eventually salvaged. For the subsequent Lloyd's Arbitration Hearing in London, the author was tasked by the Department of Justice of Canada to provide evidence for presentation at the hearing. This paper presents a brief account of the incident, the technical investigation, the technical disputes, and provides recommendations for future salvage operations.

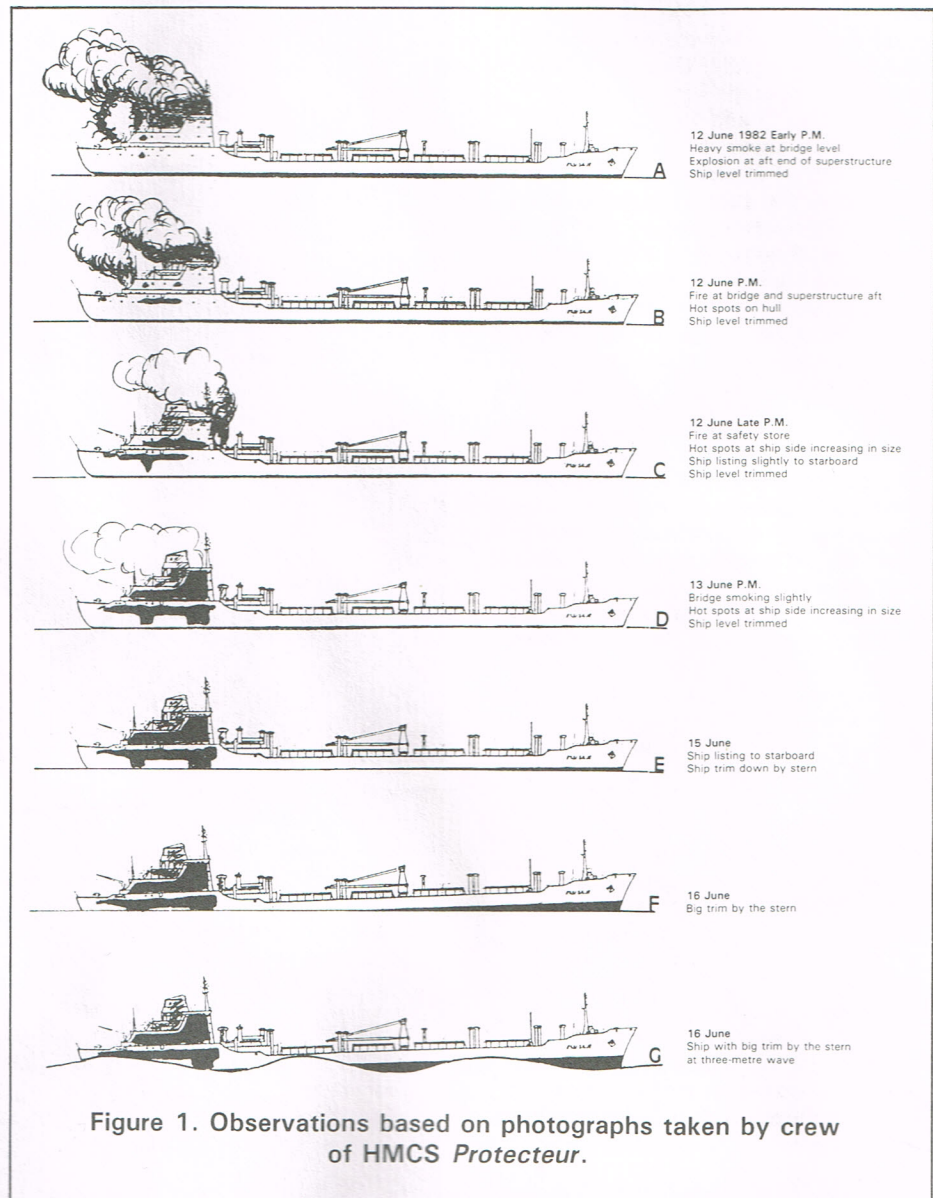
Figure 1. Observations based on photographs taken by crew of HMCS *Protecteur*.

on the bridge was out. Figure 1 shows the condition of the vessel at different time periods, based on the photographic record of the crew of *Protecteur*. Figure 2 shows actual photographs of the burning superstructure.

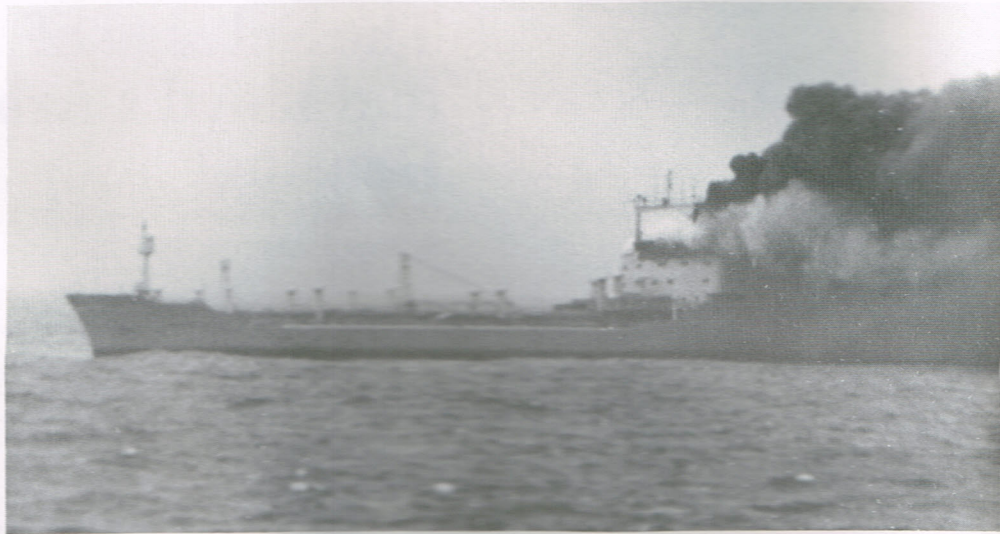
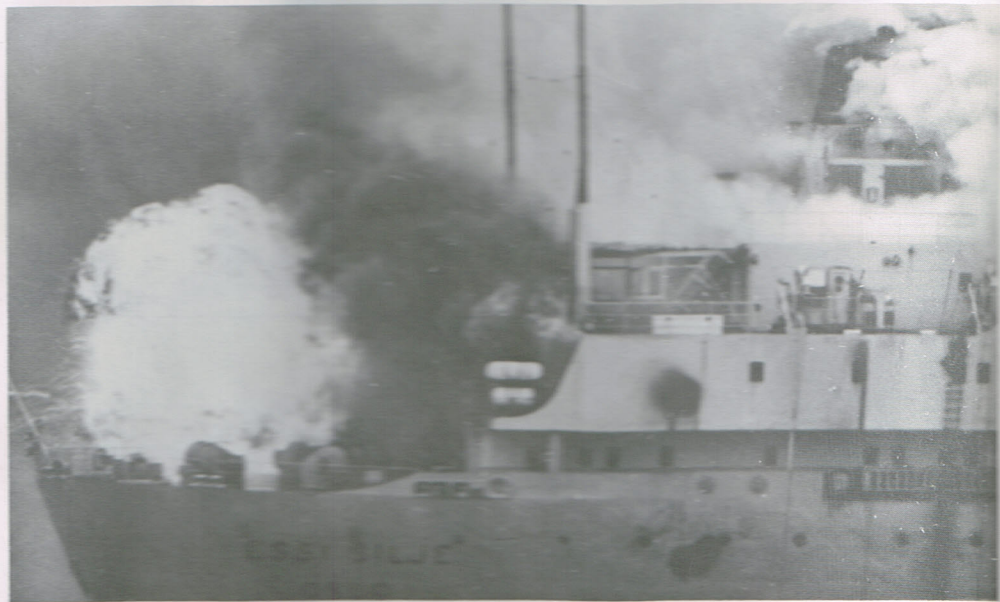
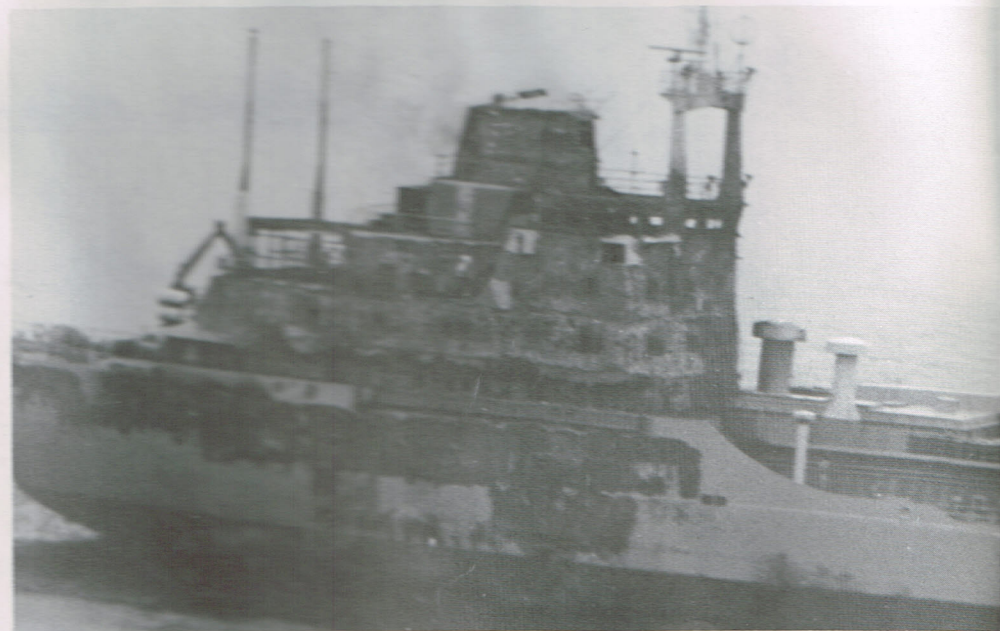
Figure 2. Bridge area of MV *Essi Silje* on fire. Note hot spots (dark patches) appearing on hull.

The flooding of the vessel was the direct result of the fire. The fire was concentrated in the after section of the vessel, abaft frame 47. Figure 2 shows hot spots at the side of the ship in way of the main deck. The peeling off of the paint indicated that a hot fire was burning inside the hull, most likely in way of the diesel fuel oil and lube oil tanks in the engine room. Because of the intense heat it is highly possible that most of the fuel tanks with their fuel lines, vents and sounding pipes were damaged and no longer watertight. Similar damage could be expected in way of the glands and stuffing boxes for the pipes or cables penetrating the watertight bulkheads, decks and side shell. In fact the flooding of the vessel was due mainly to the failure of the seawater inlet to the evaporator and the condenser, where the non-metallic parts were destroyed by the fire.

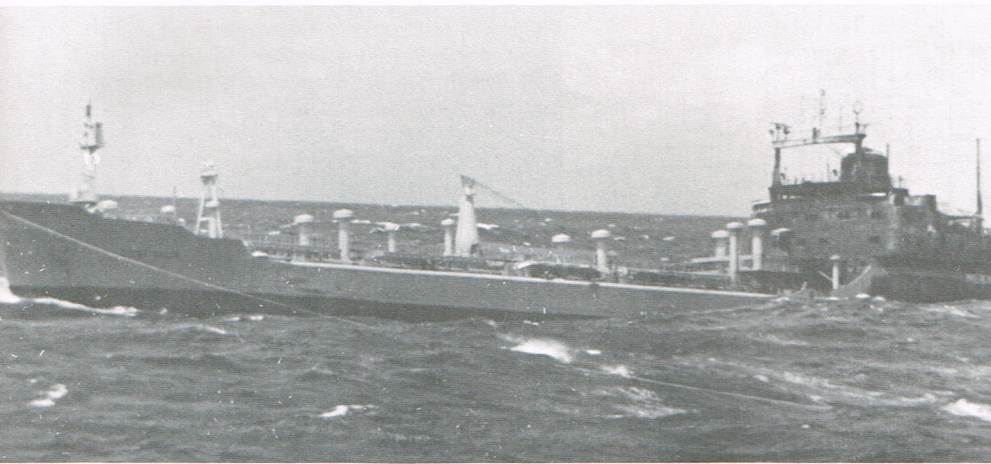
Figure 3. MV *Essi Silje* down by the stern.

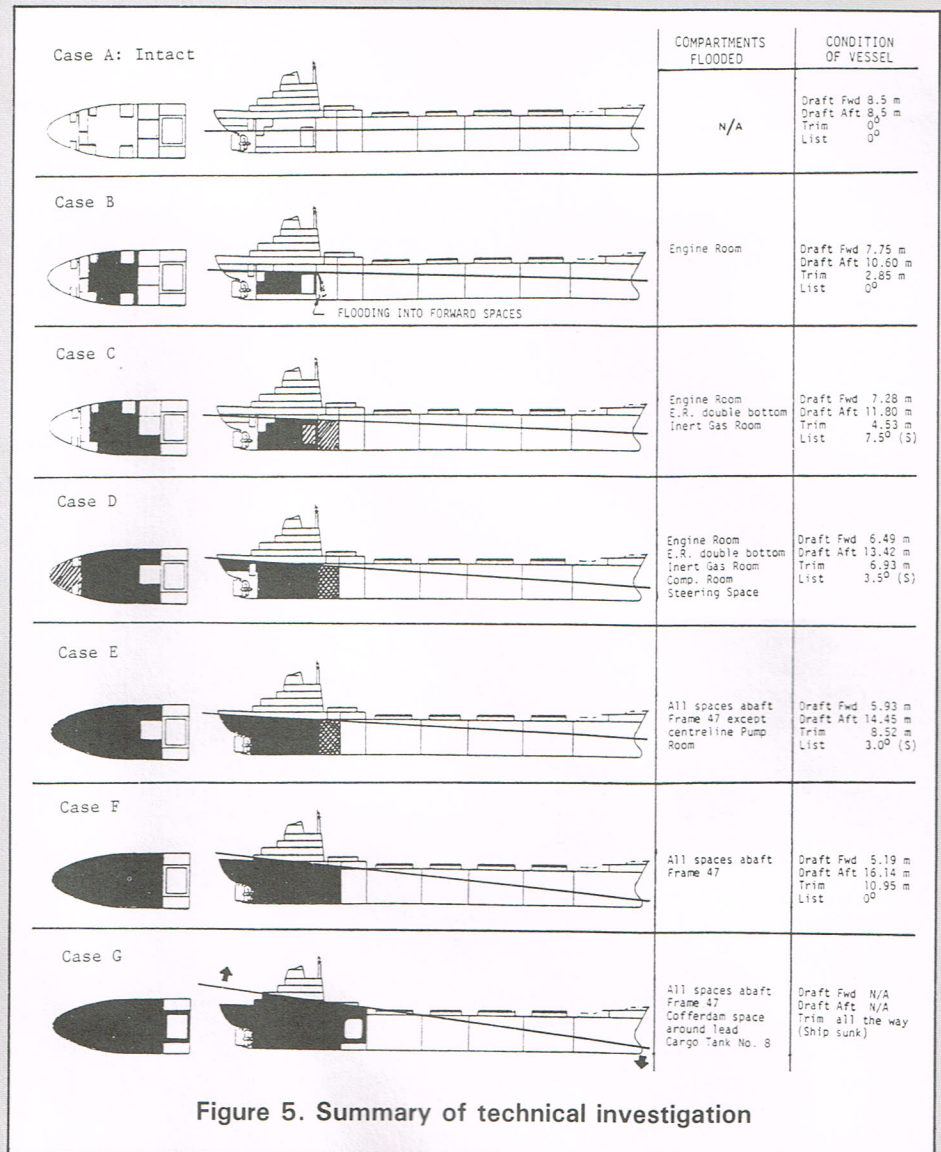
Figure 5. Summary of technical investigation

More than 30 cases of flooding were investigated and the key conditions are summarized in Figure 5. Case B of Figure 5 demonstrates that once the engine room is completely flooded, the water level will be above the doors at

bulkhead frame 37. If the doors are non-tight, the water will flood into the forward spaces. Case G demonstrates that if all the spaces abaft frame 47 and together with the cofferdam around the cargo tank No. 8 are flooded, the vessel would sink by the stern. The investigations also showed that the vessel had maintained enough margin of stability under all stern flooding conditions that there would be no danger of capsizing.

The worst trimming condition of the vessel observed by the crew of *Protecteur* was somewhat similar to Cases D and E of Figure 5. The actual trim of the vessel was unknown because no freeboard or draft readings were taken during the salvage. Also, the time when the photographs showing the various trimming situations were taken was not recorded. The result was that it was not possible to deduce the rate of flooding and sinking of the vessel.

Once the engine room was completely flooded, as indicated in Case B of Figure 5, the water could flood into the forward spaces through the two doors on bulkhead frame 47 on the main deck. It is unknown whether they were watertight doors, but the photographs show that both the doors and their frames were greatly distorted by the fire. It was suspected that the wing spaces forward of frame 47 were flooded before the doors were under water, possibly as a result of leaking pipe glands on the watertight bulkhead damaged by the fire. It might also be possible that the watertight integrity of the bulkhead was destroyed. There was no report on the condition of the bulkhead or its penetrations, and no photograph of the area was taken. Therefore, the method by which the wing spaces such as the hydraulic power pack room, the compressed air space and the inert gas space were flooded could not be determined, and the floodwater was assumed to have passed through the doors. It is possible that the starboard

wing space was flooded first, because the observed eight-to-ten-degree list to starboard at one time may be similar to Case C of Figure 5.

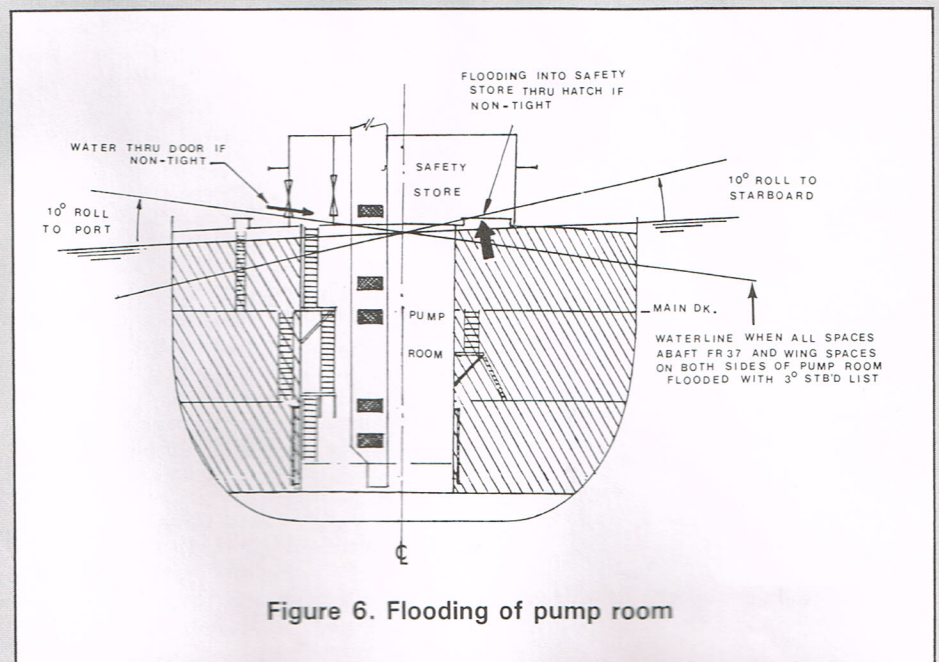
Figure 6. Flooding of pump room

the cover, if any, would have been destroyed. A vent trunk joining one of the ventilators passed through the safety store to the pump room below with a vent opening a few inches above the deck of the safety store. The water coming into the space through the hatch would rush to the port side when the vessel rolled to port, and drained into the pump

room below. Figure 6 demonstrates such a possibility for a three-degree listing to starboard and under a ten-degree roll. On the other hand, there was a chance that the hatch might still be watertight. Without taking the rolling of the vessel into consideration even if water was able to enter the space through the hatch, the amount might have been small, and with

the vessel listing to the starboard it would be an uphill run for the water to reach the vent opening. Under such circumstances the flooding scenario of the pump room might be remote.

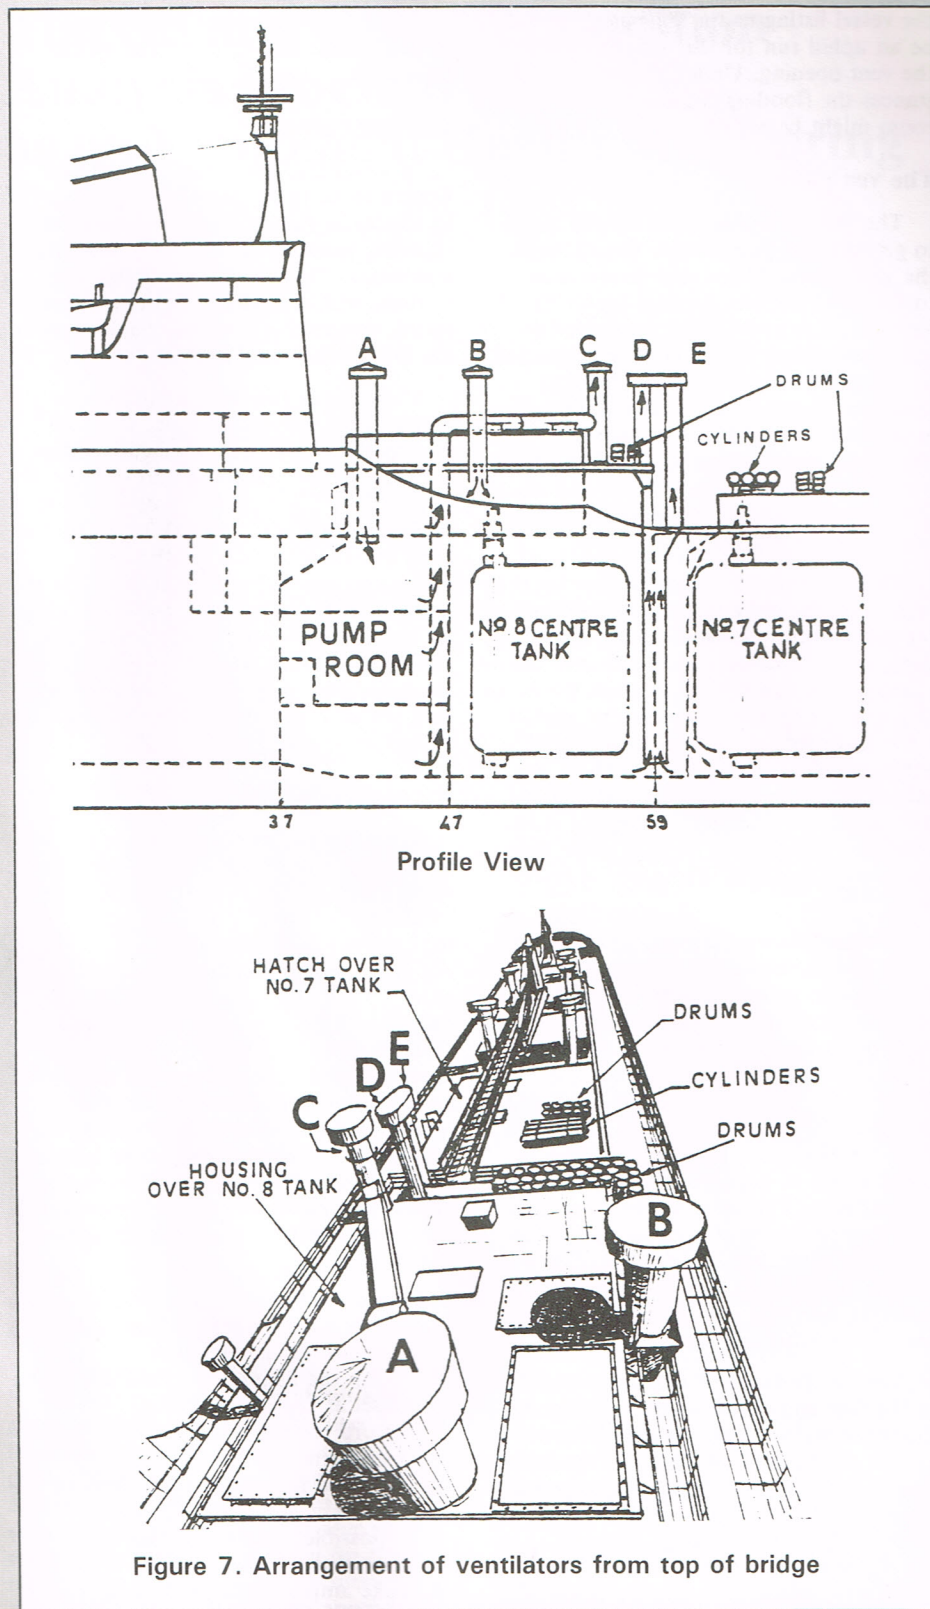
Figure 7. Arrangement of ventilators from top of bridge

The third possible route for the water to get into the pump room was through the ventilators. There were five ventilators around the No. 8 cargo tank (Fig. 7). Ventilators A and C were connected to the pump room, B and D were connected to the cofferdam around No. 8 cargo tank, and E ran into the cofferdam around No. 7 and No. 6 cargo tanks. Therefore, the risk of the vessel becoming a total loss depends on whether any of those five ventilators might be damaged and allow the ingress of sea water.

Ventilators D and E were tied together at the fore end of the hatch housing. At the trimming condition, the main deck area at the base of ventilator E would be awash under a 12-ft (3.5m) wave, and the wave most likely would break at the front of the hatch housing. Directly on the starboard side of the base of ventilator D were drums of unknown material and, on top of the hatch above cargo tanks 6 and 7 were long torpedo-shaped steel cylinders (Fig. 7). If some of these drums and cylinders had been torn loose under constant wave impact, the ventilators, especially E, not only might have been subjected to wave impacts but also there could have been damaging collisions of the drums and cylinders. If sea water had been allowed to flood into the large

cofferdam around cargo tanks 6 and 7 through ventilator E, the vessel would have sunk.
