ELECTRICAL REPORT - H.M.C.S. "WALLACEBURG"

ELECTRICAL REPORT

REPORT ON WORKING UP OF H.M.C.S. "WALLACEBURG" (Algerine)

COLLISION - H.M.C.S. "WALLACEBURG" and
H.M.C.S. "GLENADA".

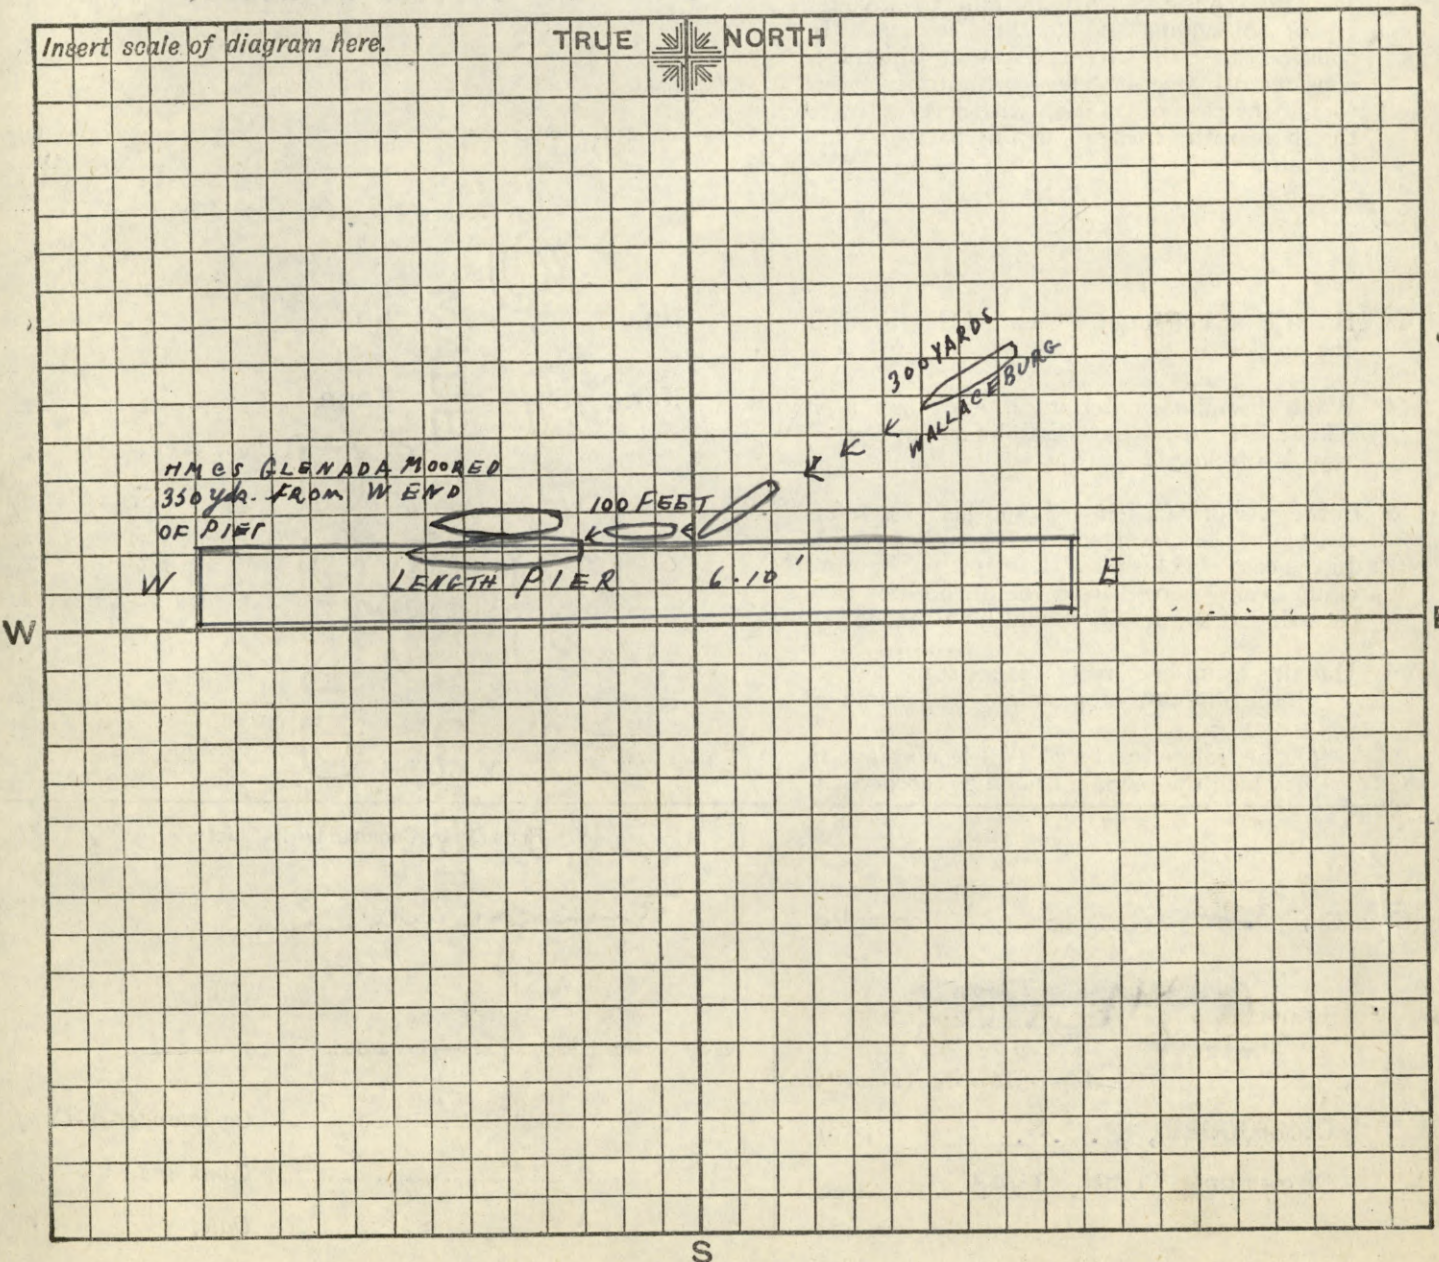
Diagram illustrating relative positions, and movements, of vessels prior to collision, to be completed, if possible, in all cases of collision.
 The diagram may also be used for the plan of the place where the ship grounded, but not for the track chart.

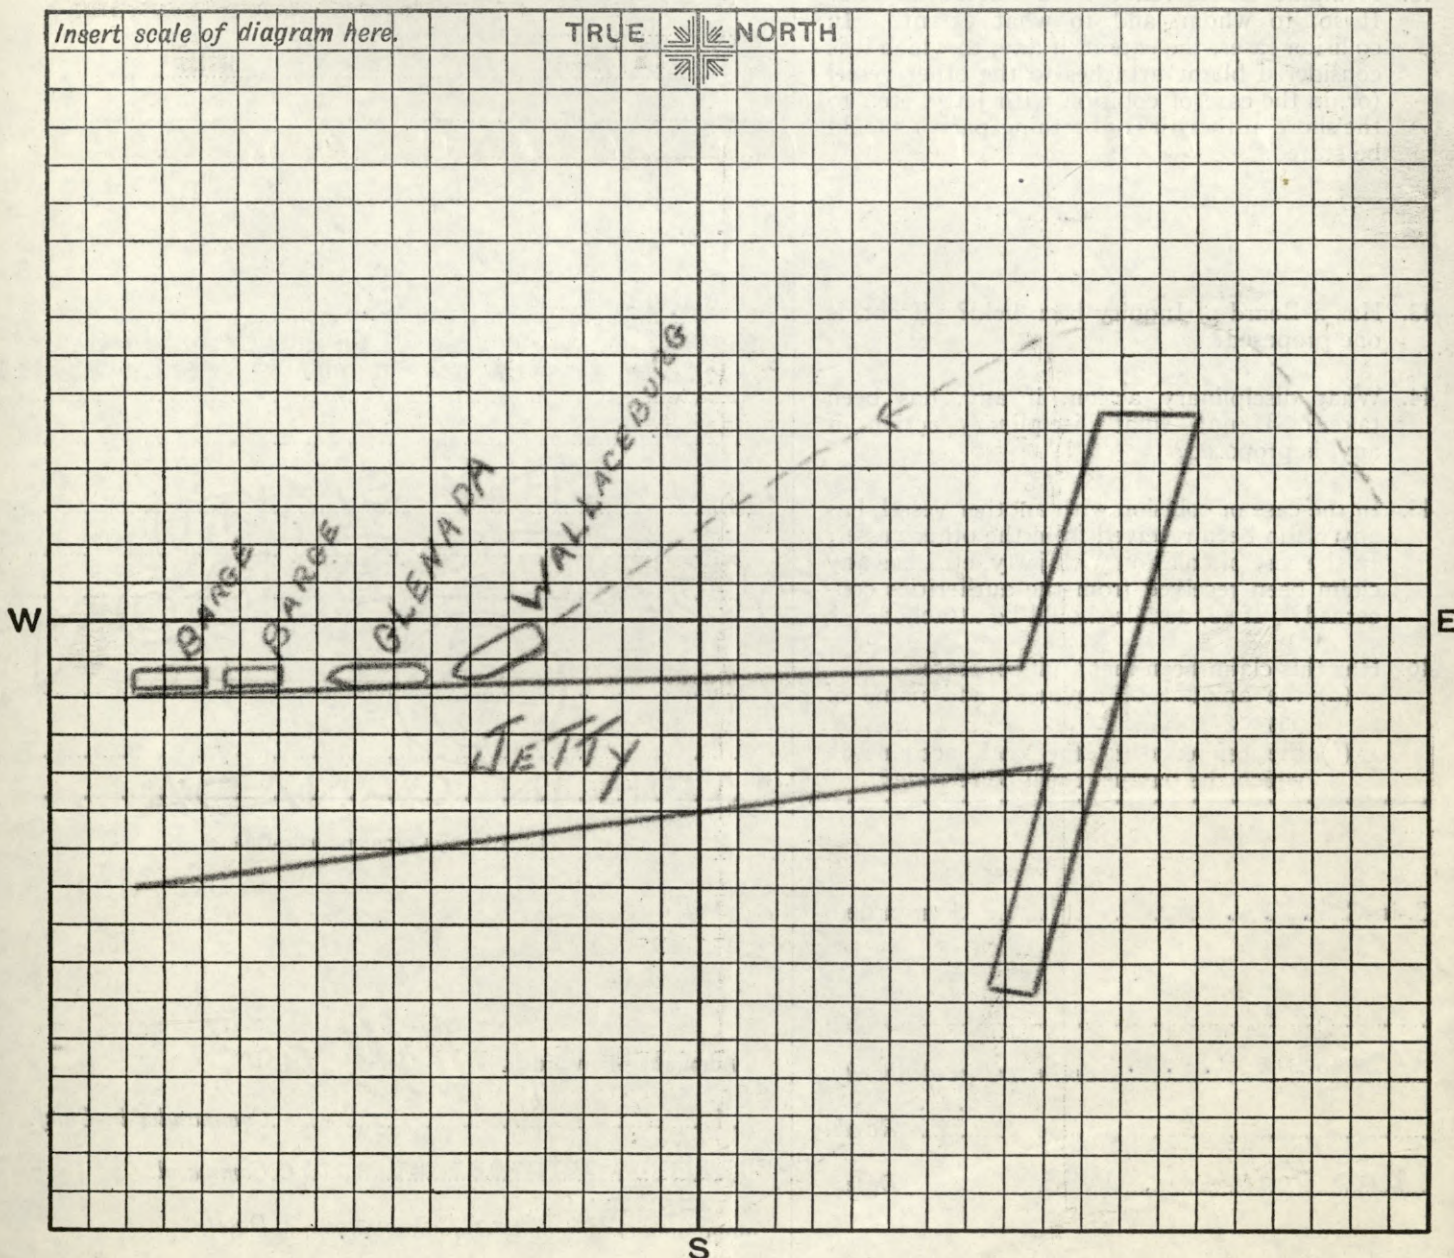
At 1545 while coming alongside the fueling jetty in St. Charles River that the H.M.C.S. "WALLACEBURG" came between H.M.C. Tug "GLENADA" and the wharf, parting all the "GLENADA's" lines and causing minor damage to her superstructure.

4. "WALLACEBURG" received a slight dint in the bow, eight feet above the water line. "GLENADA" lost a light, port rail bent, port bridge eyebrow damaged.

Diagram illustrating relative positions, and movements, of vessels prior to collision, to be completed, if possible, in all cases of collision. The diagram may also be used for the plan of the place where the ship grounded, but not for the track chart.
