The Salvage of MV *Essi Silje* and Lloyd's Arbitration Hearing¹

by Edwin S. Chan

In 1982 the chemical tanker MV *Essi Silje* caught fire and was abandoned in the North Atlantic. The Canadian naval supply ship, HMCS *Protecteur*, undertook the salvage operation before the arrival of the salvage tugs. The vessel was eventually salvaged. For the subsequent Lloyd's Arbitration Hearing in London, the author was tasked by the Department of Justice of Canada to provide evidence for presentation at the hearing. This paper presents a brief account of the incident, the technical investigation, the technical disputes, and provides recommendations for future salvage operations.

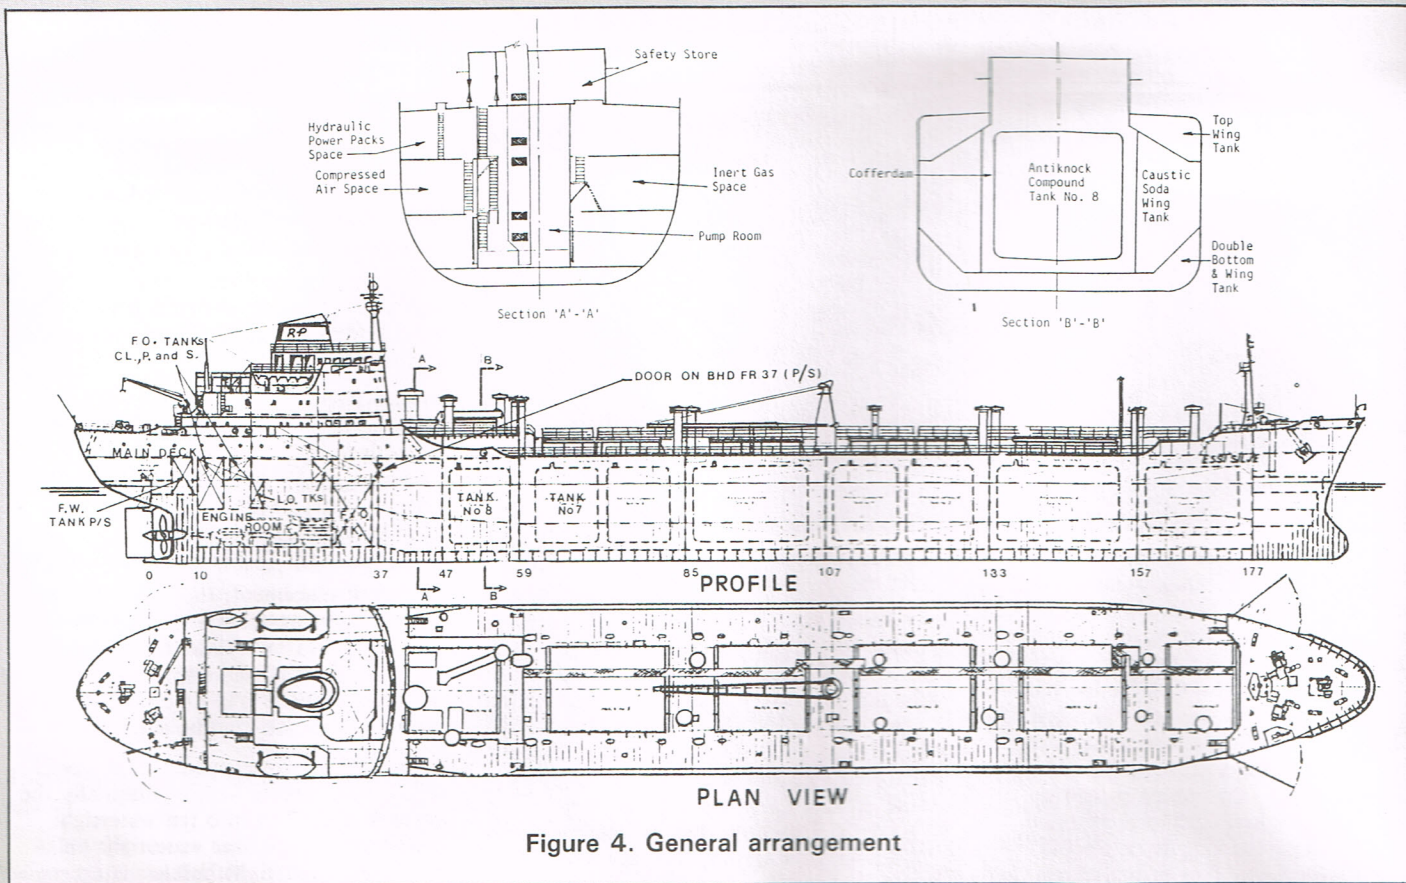
Figure 4. General arrangement

A general arrangement of the vessel is shown in Figure 4. Longitudinally the vessel was divided into ten watertight compartments by nine watertight bulkheads. All watertight bulkheads except the one at frame 37 were tight all the way to the main deck. There were two doors on bulkhead frame 37 at the level between the main deck and the second deck. It is unknown whether the doors were watertight.

The engine room was located below the accommodation between frames 10 and 37. Fuel tanks were located in the engine room.

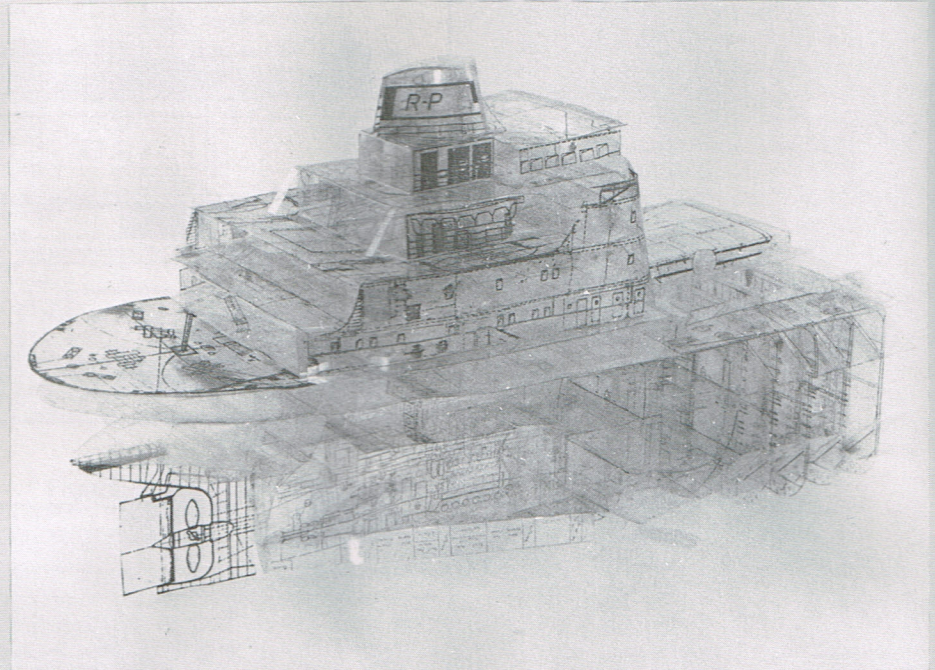
This rough, three-dimensional model of the after section of Essi Silje became an important piece of evidence during the 1984 arbitration hearing. Constructed by the author from transparencies of the ship's general arrangement drawings and structural plans, the model clearly showed key locations and arrangements on the vessel. (DND Photo by Cpl Paul Howe)
